WHY IS THE LIP THERE?

HOW TO AVOID THE PROBLEM?

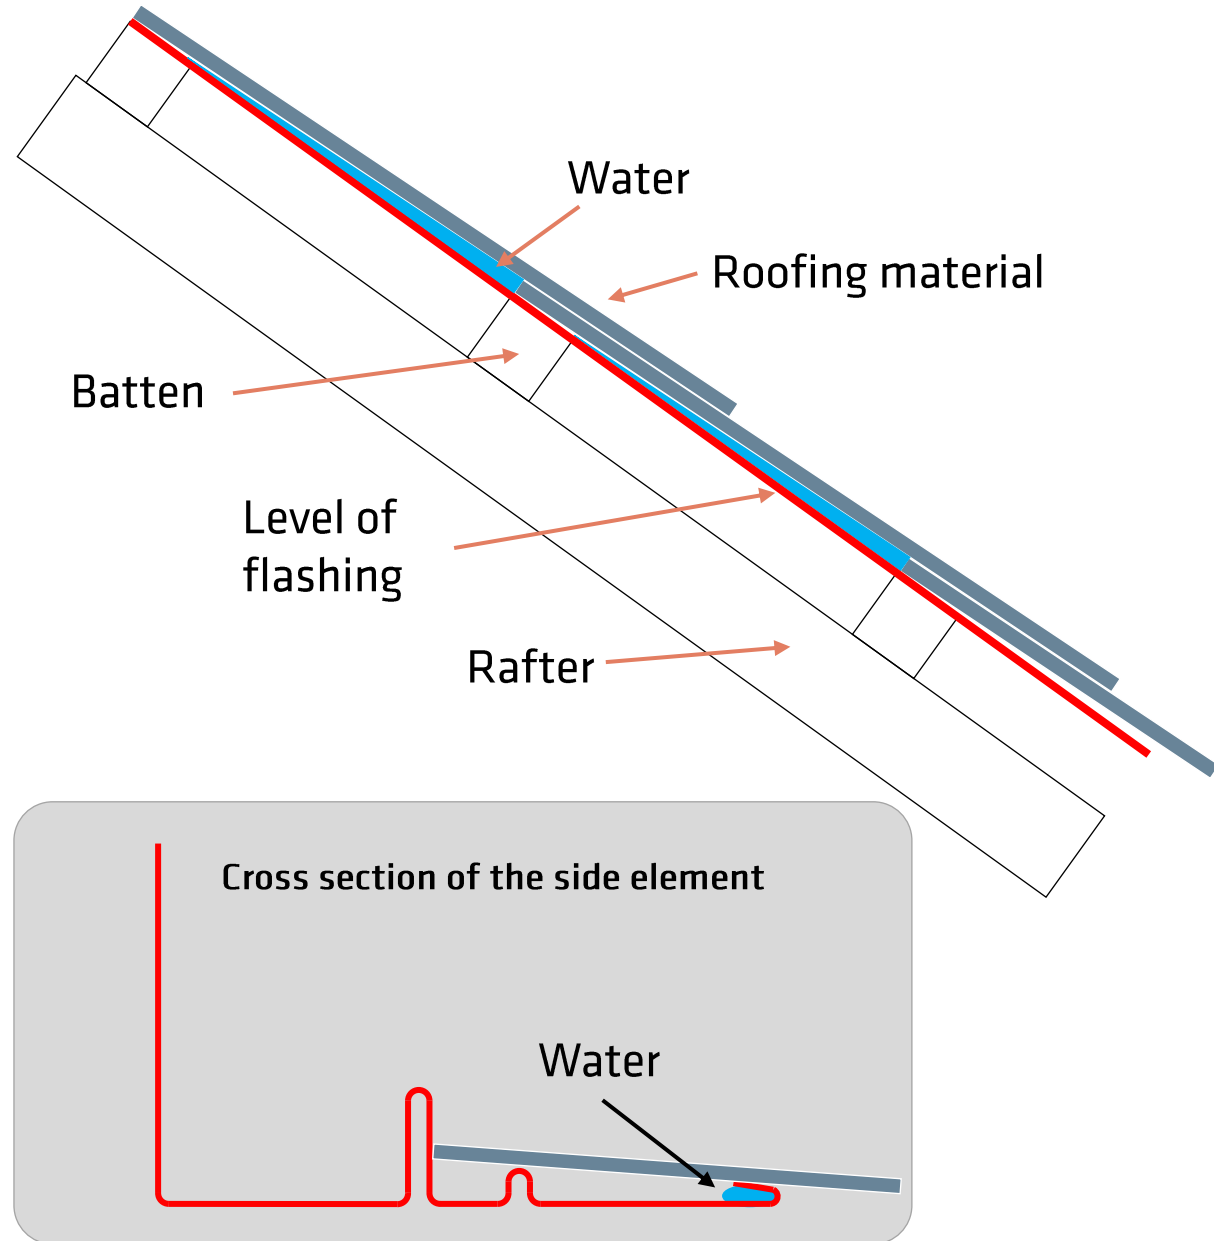
- The overlapping roofing material (e.g. slates) result in a small “hole” where the rain water can flow underneath the slates and may cause water leakage around the window
- The upstanding lip makes a water barrier that drains the water away even if the upstand is little
